Report of Expert Mr. Ernesto Baca, P.E. Judicial Inspection of Well Sacha-94

María Aguinda et al v. ChevronTexaco Corporation
Proceeding No. 002-2003, Superior Court of Justice, Nueva Loja, Ecuador

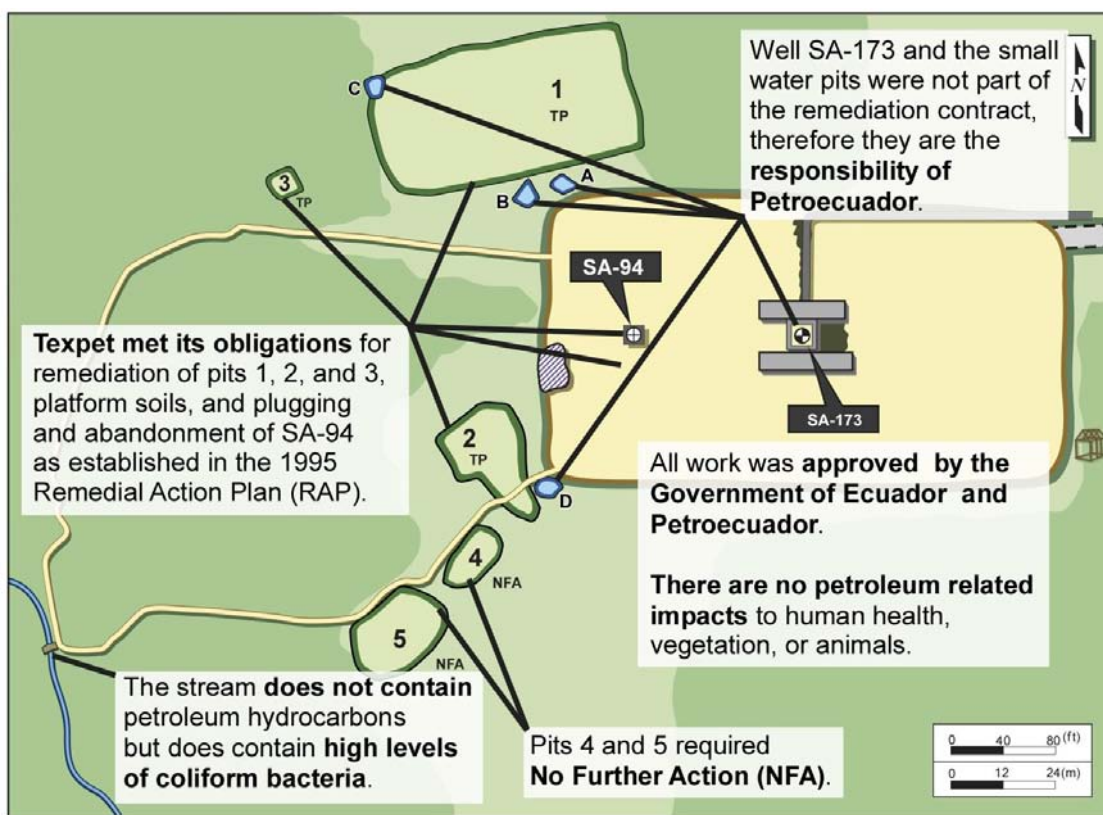
The main conclusions of the Judicial Inspection of well Sacha-94 (SA-94) are summarized in the following illustration and in the report that follows.
